U.S. Fire Administration / National Fire Academy

*Coffee Break Training***Topic: Microbiologically Influenced Corrosion (MIC)**

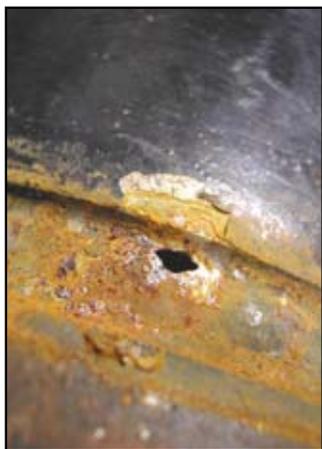
The tiny hole in the rolled groove in this picture is a sprinkler fitter's nightmare: a small leak that potentially causes water damage to the building or contents where the sprinkler system is installed.

This leak was caused by *Microbiologically Influenced Corrosion (MIC)*, also known as *bio-corrosion*. It is the result of the metabolic action of microbial cells in contact with a metal surface, and can cause pitting, crevice corrosion, selective de-alloying, stress corrosion cracking, and deposit corrosion. Iron-oxidizing bacteria, such as *Gallionella*, *Sphaerotilus*, *Leptothrix*, and *Crenothrix*, are the leading sources of MIC.

The microorganisms get into the fire sprinkler piping system through the water supply. The organisms are aerobic (oxygen consuming) and develop clusters that live off the oxygen in the water or air in a dry-pipe system. Once these microbial clusters develop, anaerobic organisms continue to grow in the stagnant water without oxygen.

Periodic sprinkler system flow tests and other activations introduce fresh water—and fresh oxygen—that spurs the growth of the oxygen-dependent MIC organisms. This is one reason NFPA 13, *Installation of Automatic Sprinkler Systems*, does not require that an inspector's test outlet be located on a remote branch line in a wet-pipe sprinkler system: the fresh incoming water brings additional oxygen to the microbes.

MIC treatments depend on the specific types of microorganisms causing the corrosion, so there is no “one size fits all” solution. One plan, introducing chlorine into a system, may destroy some of the microorganisms, but it also may result in other types of corrosion. It's essential to obtain a sample of both the sprinkler piping and the water in the system to determine which microorganisms are causing the corrosion and select an appropriate treatment plan. Many sprinkler component manufacturers now produce “corrosion testing stations” to evaluate the water's condition.
