## Means of Egress: Fire Exit Hardware Details

No. FP-2010-17 April 27, 2010

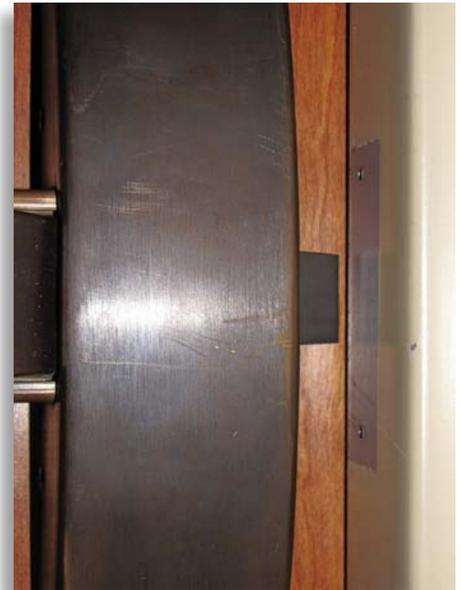
Today’s Coffee Break is another illustration of that important point. When you look closely at the photograph, you will see that the exit hardware strike plate is missing from the door frame. The strike plate is an important component in this assembly because the latch bolt in the exit hardware rests in the strike plate to hold this door closed.

The strike plate is missing from this exit hardware device, compromising its ability to hold the door closed.

While it may seem to make sense to allow an egress door to swing freely, in this example, the fire exit hardware is an important part of the building’s fire-resistant construction. (See Coffee Break Training 2007-43 for the difference between “panic” and “fire exit” hardware.) This door opens from an occupied room into a 2-hour fire-resistance-rated exit enclosure, and is in the direct path from the building to outdoors.

Should a fire occur in the room, the increased air pressure caused by the rising temperature (Gay-Lussac’s or Charles’ Law) could push this door open and enable products of combustion to contaminate the stair enclosure. When the latch bolt is held in place by a strike plate, this failure is less likely to occur.

Inspector’s should always look closely at all the components of a fire assembly to confirm they are in place, and where possible, test the assembly to verify it will close and latch as it is designed to do. If important components are missing or the fire assembly is compromised, that information should be documented and reported to the building owner or occupant for repair.
