U.S. Fire Administration / National Fire Academy

Coffee Break Training

Topic: Housekeeping

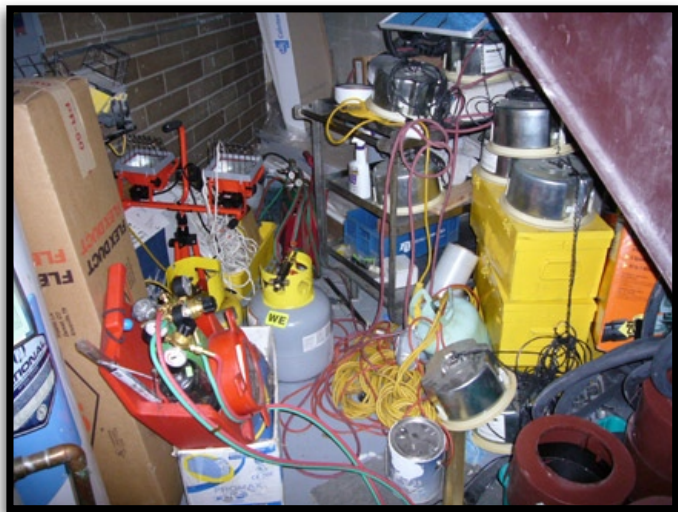
This photograph was taken of a storage area beneath exit stairs in a large convention center with an occupant capacity of several thousand persons. The accumulation and variety of combustibles in a small space is surprising.

Look closely and you will see ordinary combustible materials, a paint can that may contain a flammable or combustible liquid, cleaning chemicals, two pressure vessels of refrigerant gases, and two portable welding kits that contain oxidizing and flammable gases.

If you look even more closely, you will see the edge of a hot water tank in the lower left-hand side of the picture that could be an ignition source for any of these items.

The variety of hazards in this photograph are almost too numerous to mention.

The model fire codes require that combustible storage in buildings be orderly and separated from heaters or heating devices by distance or shielding so ignition cannot occur. The codes also prohibit storage in mechanical rooms or electrical rooms.

In nonsprinklered buildings, storage should be arranged so it is at least 24 inches (610 mm) below the ceiling, and in sprinklered buildings at least 18 inches (457 mm) below the level of the sprinkler deflectors.

This circumstance should be brought to the attention of building management to have this hazardous condition corrected.
