Automatic Sprinklers: Sprinkler Obstructions from Poor Quality Control

No. FP-2010-44 November 2, 2010

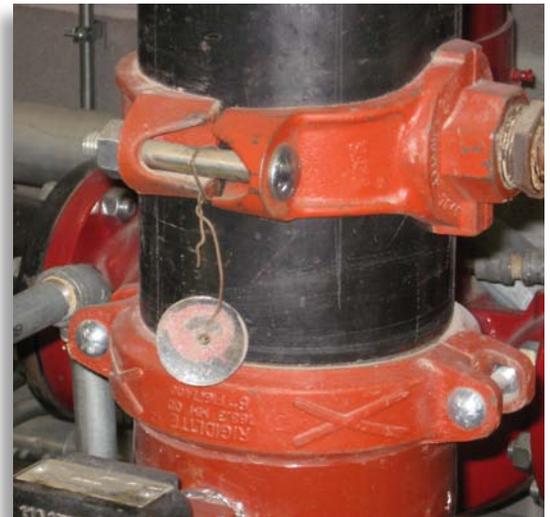
The small round disk hanging on the wire in the upper photograph is called a “coupon.” When a sprinkler installer bores into a pipe to install a flow switch, pressure switch, sprinkler nipple, or some other attachment, there is a very real danger that the portion of the pipe that is cut out—the coupon—might fall into and remain in the sprinkler pipe. If one or more coupons accumulate in the pipe—as illustrated in the lower photograph—there is a very real chance that water flow will never reach a sprinkler to control or suppress a fire.

By hanging this coupon on the fitting bolt, the sprinkler installer has provided an indication that he/she captured the coupon when boring the hole, and it did not fall into the pipe. This is a common practice among sprinkler installers to provide some confidence for the inspector. Is this absolutely the coupon that came from that hole? There really is no way to verify it without dismantling the attachment and checking to see if the coupon fits like a jigsaw puzzle piece.

These two photos represent differences in attention to detail in fire sprinkler pipe installation.

The most reliable way to ensure coupons have not accumulated in the pipe is to conduct internal visual inspections; however, this normally is not feasible during the initial sprinkler system installation. Another technique is to fill the sprinkler system slowly with water and listen for the telltale signs of the residual metal pieces as they hit the interior pipe walls. Anytime the inspector suspects there is an obstruction, the pipe should be dismantled and physically verified that there is nothing that would interfere with water flow.
