U.S. Fire Administration / National Fire Academy

Warning: Hot Coffee!**Topic: Fire Door Inspections**

Learning objective: The student shall be able to identify components of a fire door inspection and test.

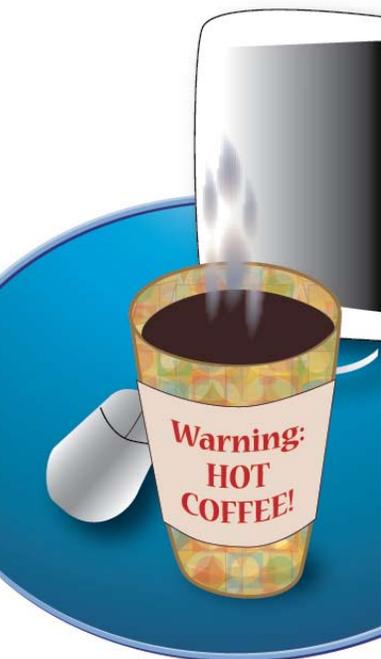
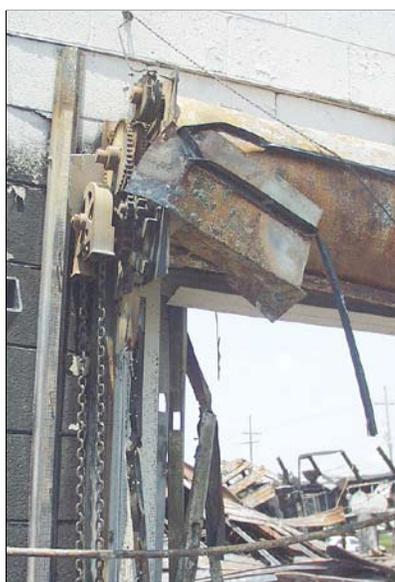
This fire door assembly failed during the Super Sofa Store June 18, 2007 fire. Photo courtesy NIST Building and Fire Research Laboratory.

Fire doors, or “opening protectives,” are an essential component in maintaining the integrity of fire-resistive barriers that have openings. Investigators have found that several of the required overhead fire doors installed in the Super Sofa Store failed to operate during the June 18 fire in Charleston, SC where nine firefighters died.
